TILTING PAD JOURNAL BEARING STARVATION EFFECTS

ABSTRACT

This paper discusses evacuated journal bearing starvation and its possible detrimental effects on rotordynamics. Specifically, the

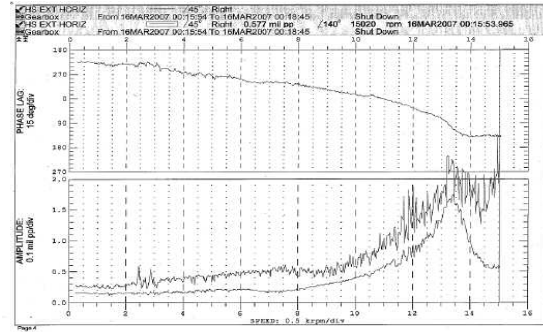
A speed-amplitude plot for the pinion from the initial no-load mechanical test run is shown in Figure 4 with a pinion bearing total oil flow of 34 gpm per bearing. For this plot and all other test results presented herein, an unbalance weight was placed on the coupling hub in order to excite and locate the pinion's first critical speed. From Figure 4, note that the pinion critical speed is evident at about $N_1 = 13,500$ rpm with an amplification factor of $A_1 = 13.5$. This does not meet the API 613 (2003) acceptance criteria. Note that the terms

Figure 4. Initial Pinion Response, $Q = 34$ gpm, $C_b = 9.0$ mils, Fabricated Baseplate.

In an attempt to match the no-load test results of Figure 4 ($N_1 = 13,600$ rpm, $A_1 = 13.5$), a rotordynamics analysis was performed on the pinion. Initially, the tilting pad bearing analysis assumed a full film as the bearing code used in the analysis did not have the capability to calculate any starvation effects explicitly (Nicholas, et al., 1979). A reasonable gearbox case support stiffness value of $K_s = 7.0 \times 10^6$ was assumed. The nominal as-shipped bearing clearance of $C_b = 9.0$ mils diametral was also used. The resulting speed-amplitude plot is presented in Figure 8. The pinion critical is predicted at 13,700 rpm with an amplification factor of 7.6. The frequency is a good match but the amplification is predicted to be about 50 percent of the actual value indicating far less damping in the system than anticipated.

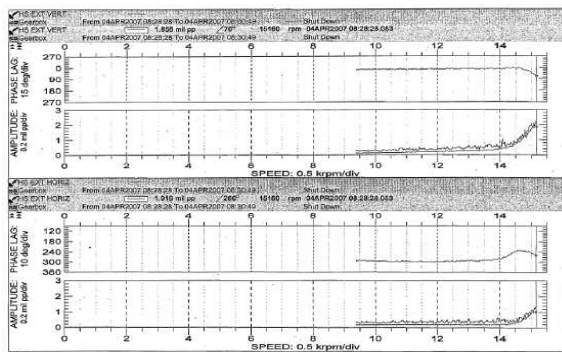
Since this still does not meet the API 613 (2003) acceptance criteria, the inlet pressure was increased from the design value of 25 psi to 45 psi in an attempt to easily check the effects of increasing oil flow. The corresponding per bearing total oil inlet flow increase was from 45 to 60 gpm. The resulting response run is shown in Figure 6 with N_1 greater than 15,200 rpm.

Figure 6. Interim Pinion Response, $P_{in} = 45$ psi, $Q = 60$ gpm, $C_b = 9.0$ mils, Solid Baseplate.

Based on the favorable Figure 6 results, another increase in oil inlet flow seemed appropriate. Further increasing the total oil flow to 55 gpm per bearing (50 gpm lubricating plus 5 gpm by-pass)

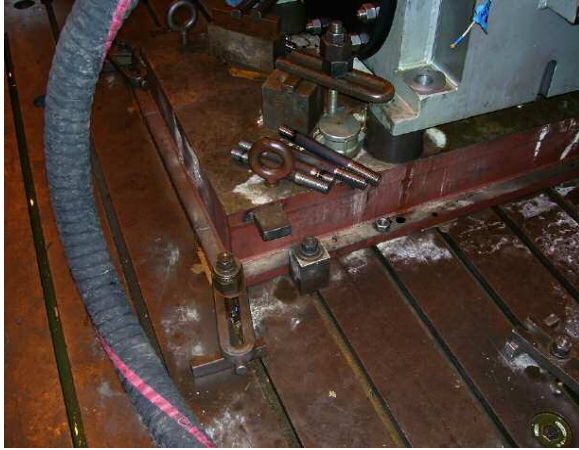
Figure 5 test results ($N_1 = 14,200$ rpm, $A_1 = 14.2$) were obtained with 45 gpm of total per bearing oil flow plus the stiffer, solid baseplate. The original fabricated, hollow baseplate is shown in Figure 9. In an attempt to increase the pinion's critical speed by increasing the gearbox support stiffness, a new solid baseplate, Figure 10, replaced the original prior to the Figure 5 test. A rap test was performed on the gearbox with the new, solid baseplate. Results indicated a dynamic support stiffness of 20.0×10^6 lbf/in at a frequency of 14,000 cpm. Using $K_s = 20.0 \times 10^6$ lbs/in and the nominal as-shipped bearing clearance of $C_b = 9.0$ mils diametral, results in the speed-amplitude plot shown in Figure 11. The pinion critical is now predicted at 17,200 rpm with an amplification factor of 5.5. The frequency is over predicted by 3,000 rpm and the amplification factor is under predicted by a factor of 2.6. These results are summarized in Table 4.

Figure 9. Original Fabricated Hollow Baseplate.

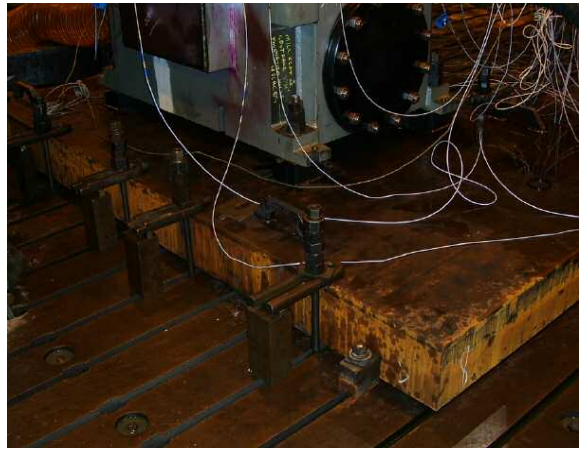
Figure 10. New Solid Baseplate.

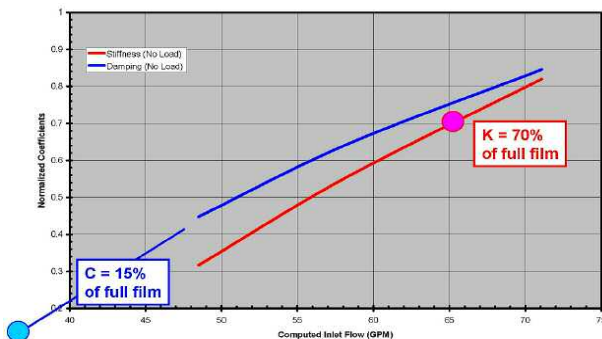
Returning to the code by He (2003), plotting the normalized bearing stiffness, K , and damping, C , as a function of lubricating oil flow results in the plot shown in Figure 14. The code does predict a drastic decline in K and C , but they decrease at about the same rate. The dots shown on the plot indicate a stiffness value that is 70 percent of full film and a damping value that is 15 percent of full film. The K value that is 70 percent of full film occurs at a predicted lubricating flow rate of 65 gpm while the C value that is 15 percent of full film extrapolates out to a lubricating flow rate of 36 gpm. Since both flow rates cannot occur at the same time, 70 percent of full film K and 15 percent of full film C also cannot occur at the same time. But, they would have to occur together in order to match the test results. Thus, it is difficult to envision a starvation model that matches the test results. These results are summarized in Table 4.

Figure 14. Starvation Model, Normalized K and C Versus Oil Flow Showing $K = 70$ Percent and $C = 15$ Percent of Full Film Values.

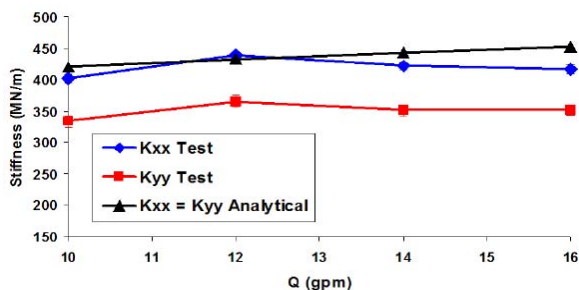
Figure 15. 4x4 Inch TPJB Zero Load Test Data—Principal Stiffness Versus Oil Flow.

From Figure 15, the test curves show a barely perceivable decline in bearing stiffness as the total oil flow decreases from a full film value of 16 gpm to a starved value of 10 gpm.

Also notice that full film analytical predictions from Nicholas, et al. (1979), are included on both plots. The nominal as-built bearing clearance was used for the analysis. Pivot stiffness was included and calculated by the Hertzian method from Kirk and Reedy (1988) and Nicholas and Wygant (1995).

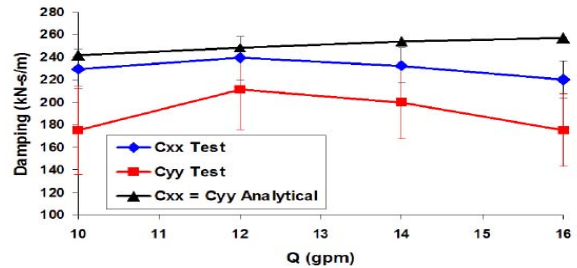
Figure 16. 4x4 Inch TPJB Zero Load Test Data—Principal Damping Versus Oil Flow.

From Figure 16, the test results indicate that the direct damping increases slightly and then declines as flow decreases. Certainly, no decrease in damping is evident from Figure 16 that approaches the 15 percent of full film value discussed previously.

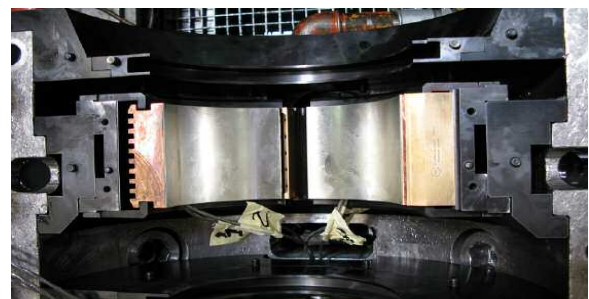
Soon after the problem gearboxes were shipped, a similar evacuated tilting pad bearing design with a 6.65 inch journal diameter was used for a high speed balance of a magnetic bearing rotor. This application is shown on the plot of Figure 1 in the extreme lower right-hand corner, 575 f/s surface velocity, 26 psi unit loading. The tilting pad bearings, used for the high speed balance only, supported the rotor on the magnetic bearing laminations. Since the laminations had a relatively large outside diameter, the tilting pad bearing surface velocity was extremely high with the evacuated bearing running up to 435 f/s. The actual bearing is shown in Figure 17. The journal surface velocity versus metal temperature plot from one of the initial test runs using the evacuated design is shown in Figure 18, blue line with solid blue circles (refer to ACKNOWLEDGEMENT section).

Figure 17. Ultra High Speed Application—Evacuated TPJ Bearing.

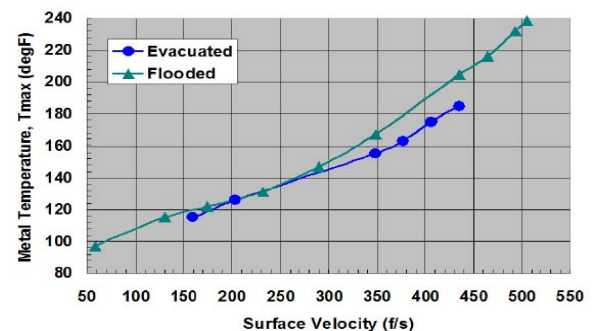
Figure 18. Evacuated Versus Flooded TPJB, High Speed Balance on Laminations.

The minimum oil lubricating flow requirement for operation at 435 f/s with the evacuated design is 36 gpm calculated as described in the OIL FLOW REQUIREMENTS section. Because of flow restrictions in the high speed balance facility, the evacuated bearings were designed for 28 gpm of lubricating flow. After the test resulting in the evacuated bearing data shown in Figure 18, it was determined that one of the oil pumps was not operational. Thus, the resulting lubricating flow was 20 gpm and the bearing ran 56 percent starved.

Furthermore, because of a misunderstanding, it was believed during the run that the oil drains were pressurized. This was not the case and the evacuated bearing operated in a vacuum, further starving the bearing due to oil atomization. Even in this extreme starvation condition, the rotor critical was located as anticipated with a reasonable amplification factor.

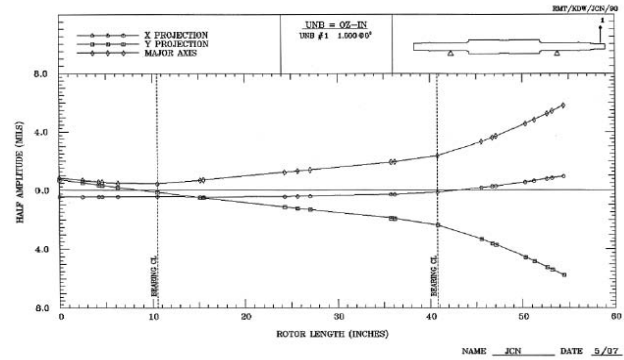
- The use of an integrally flanged coupling with a low overhung moment is highly recommended. From the pinion mode shape illustrated in Figure 20, the pinion critical is clearly controlled by the coupling end overhang moment. This pinion coupling employed a shrunk-on hub. An integral flange attachment would greatly reduce the overhung moment. From Figure 13, $N_1 = 14,700$ rpm and $A_1 = 11.3$ with a coupling hub attachment. This analysis used the artificially degraded bearing stiffness and damping properties to match the test results. Replacing the hub attachment with an integral flange attachment with a lower overhung moment, results in Figure 21. Now, $N_1 = 16,200$ rpm and $A_1 = 9.0$ and this problem would not have materialized. For this gearbox, there were no engineering reasons to use a hub attachment instead of an integral flange.

Figure 20. Pinion Mode Shape with Coupling Hub Attachment.

- The use of an integrally flanged coupling with a low overhung moment is highly recommended. If one were used on this application, this problem would not have occurred.
